Jonathan Burton¹, Daniel Orfeo¹, Tian Xia², Dryver Huston¹

¹Department of Mechanical Engineering, ²Department of Electrical and Biomedical Engineering
University of Vermont

HIVE-II

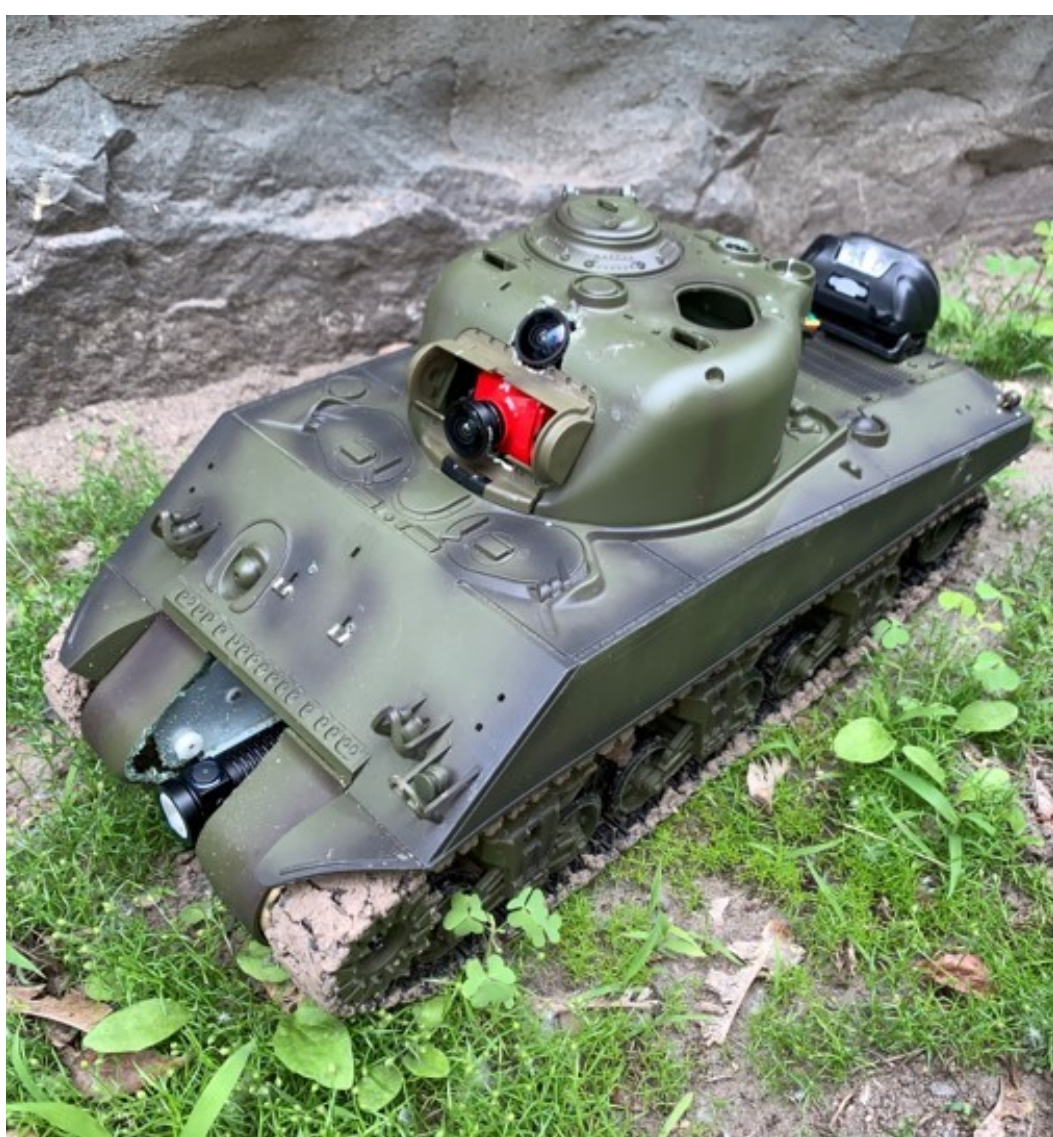
Figure 1. Left: the HIVE-II. Right: comparison of HIVE-II versus original HIVE.

A Heng Long 1/16-scale remote control toy tank was chosen for the HIVE-II chassis due to its compact size, low cost, and continuous tracks. Continuous tracks allow it to meet VTrans requirements to span a 6-inch (152 mm) separation gap and remain stationary on a 20-degree slope. Optimal equipment for radio control and video transmission through small culverts is understood through theoretical analysis and a series of field tests. Total materials cost of the HIVE-II is less than \$1,500.

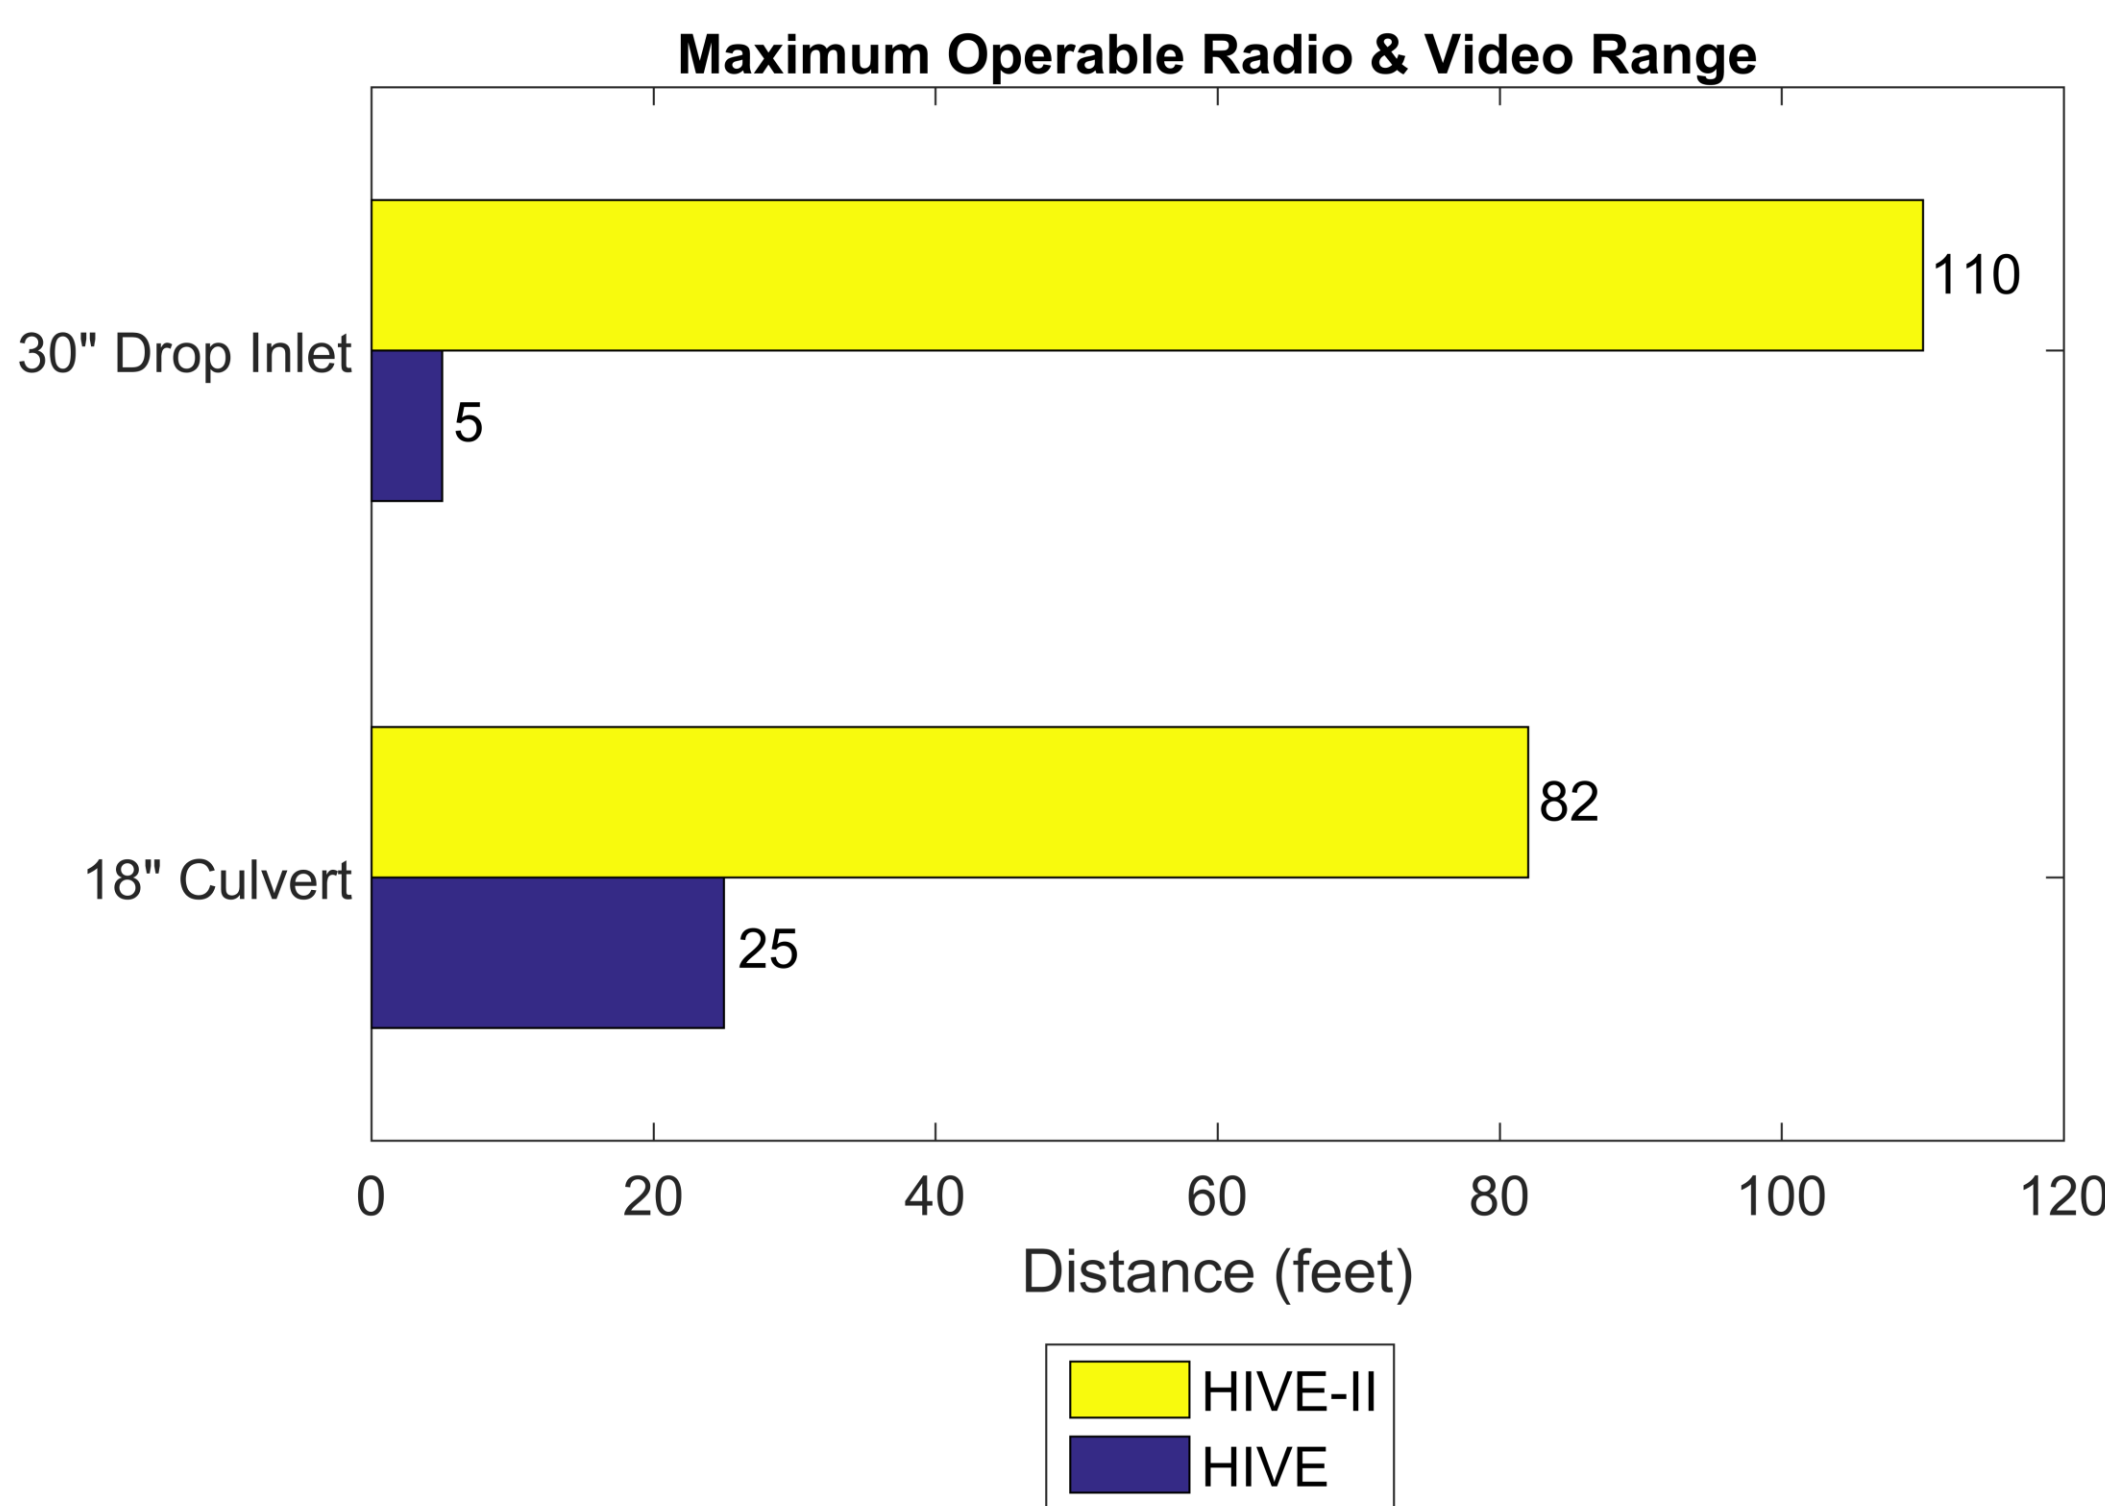
Performance of HIVE-II versus original HIVE
(Longer bars are better)

The original HIVE is quite capable but has limitations, Table 1. The HIVE-II offers much greater operating range, improved capability to traverse obstacles and gaps, and precise distance encoding from a tether spool with a digital revolution counter. Figure 1 shows that the HIVE-II equipped with a 5.8 GHz video transmitter provides 100+ feet (30.5+ m) of additional range when operating in a 30-inch (752 mm) drop inlet, and 50+ feet (15.2+ m) of additional range when operating in an 18-inch (457 mm) culvert.

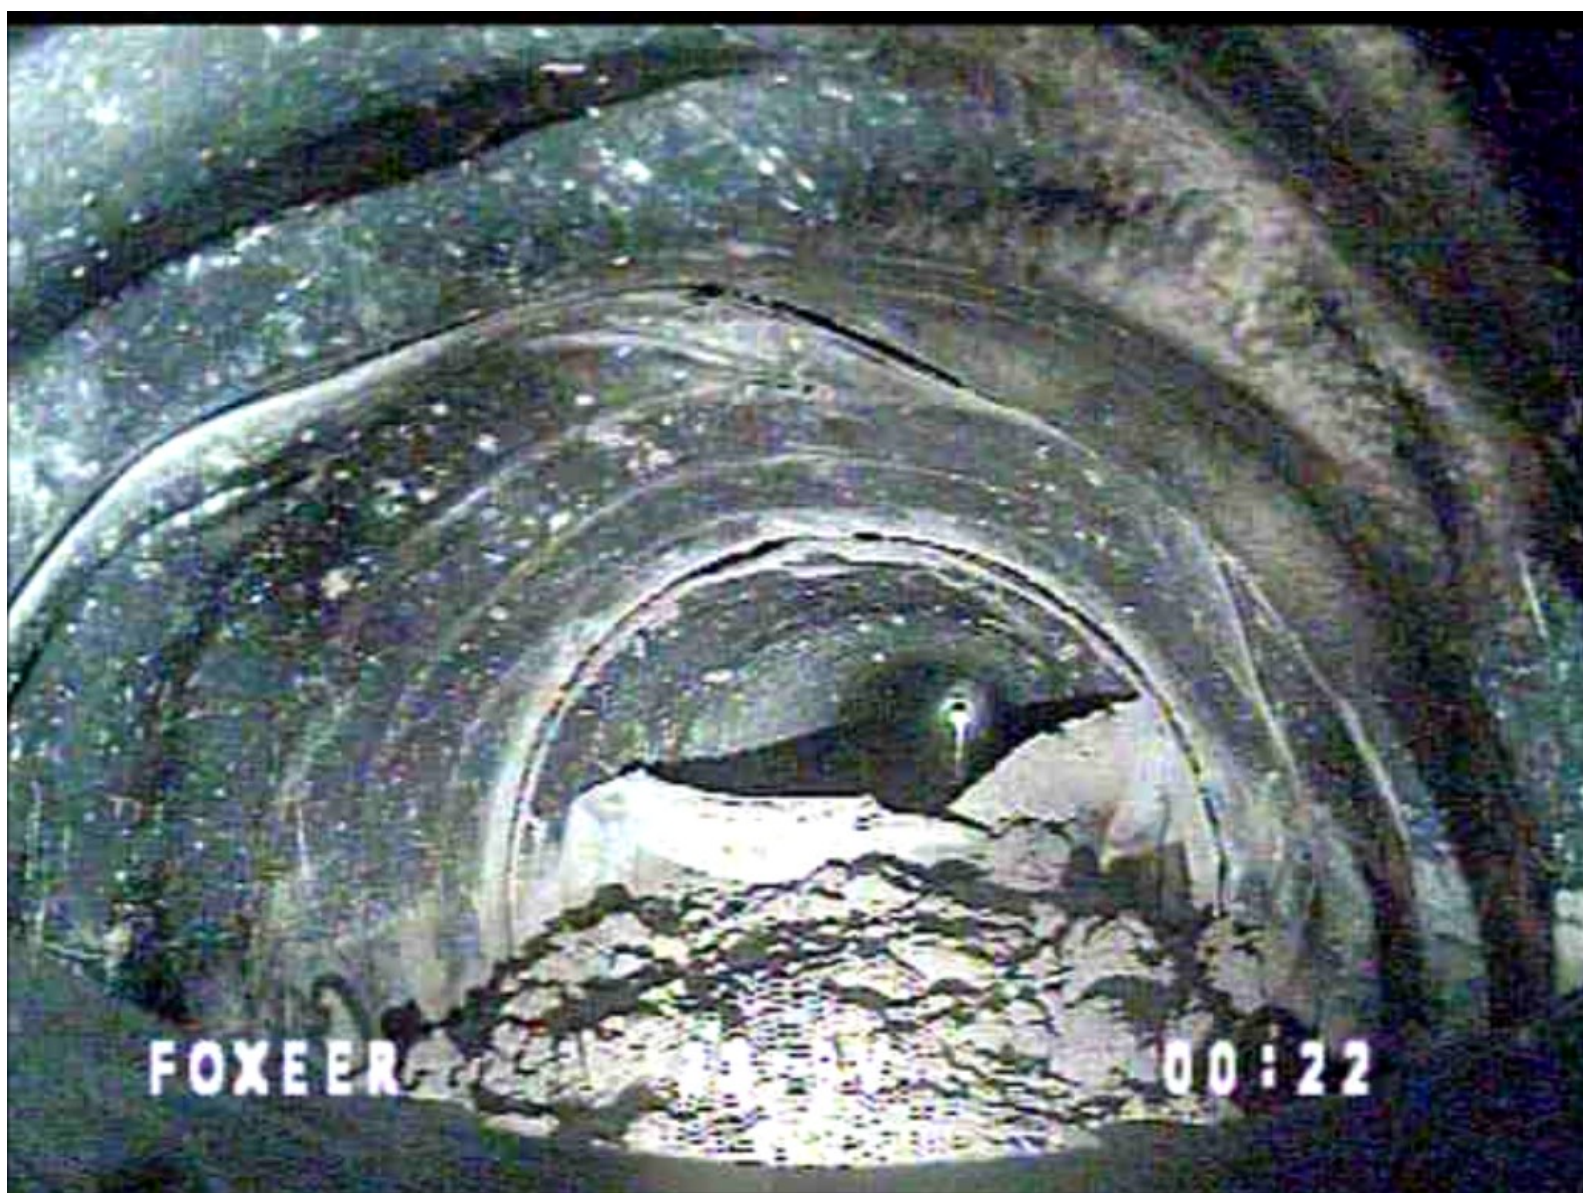
Figure 2. Photographs from the HIVE-II. Left: a partial blockage has caused sediment buildup in the culvert. Right: the culvert is clear after traversing the partial blockage.
